Truck inspections on the fly

Delta piloting technology that detects faulty vehicles by aiming a camera-like device at them as they roll by

The Delta Optimist

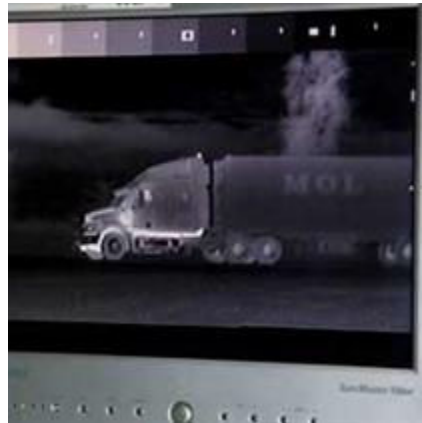
CREDIT: photo by Brett Beadle
A truck is captured on a thermal imaging screen using technology Delta is piloting.

Hallett said the passive nature of the technology -- the operator sits inside the van and simply points a camera-like unit at the trucks -- means a much higher volume of commercial vehicles can be checked in a shorter amount of time.

The camera unit employs infrared radiation as a visible image on a monitor. The monitor will display a more intense radiation image if it detects a commercial vehicle with a hot spot, such as bad brakes.
